FSB NUMBER: FSB10868
APC: 481, 756
DATE: May 2014
EXPIRES: 30-Apr-2015
BULLETIN TYPE: Informational Only

FIELD SERVICE BULLETIN

SUBJECT: ASTRO® Digital APX™ 6000 and APX™ 6000XE (7/800 MHz) “Accy hardware not available” or “USB overcurrnt” error code when pressing PTT and may exhibit a loss of transmit audio thru a remote accessory.

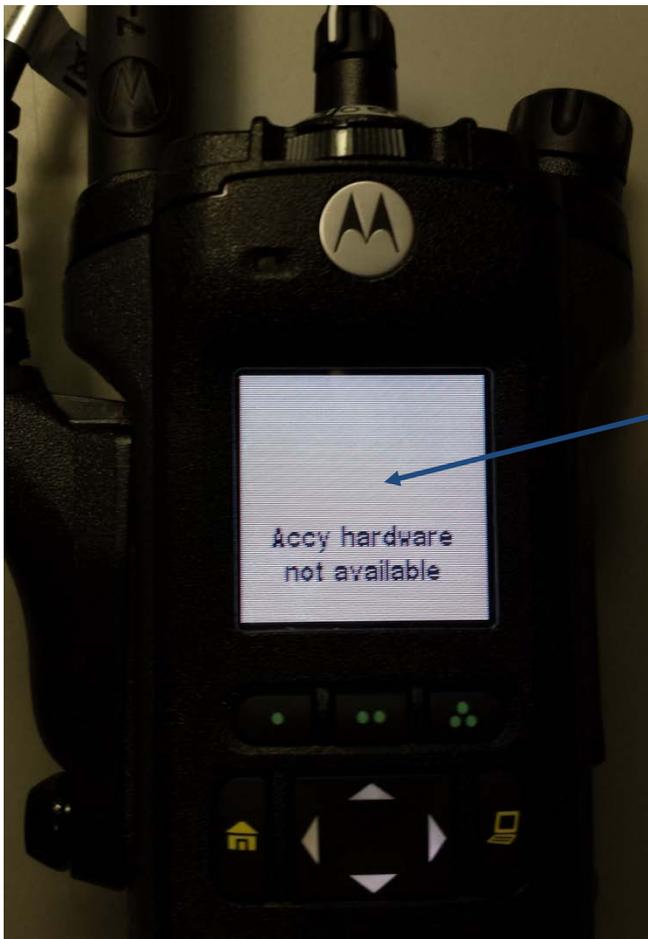
7. Press the accessory PTT button 10-15 times while moving the cable around the antenna and watch for the top or front display to flash the error messages listed in this FSB. The error message clears after approximately 1 second.

Example of Error Message. For model I radios check top display for similar error messages

8. If the error message does not appear, cycle the radio power and repeat the test 4 more times or until the message appears.
9. If no error message appears, the radio is good. No further action is required.
10. If error message appears, the radio is impacted and needs to be returned to Motorola Solutions, Inc. for repair (See resolution section for instructions to return for repair).
