FSB NUMBER: FSB10868
APC: 481, 756
DATE: May 2014
EXPIRES: 30-Apr-2015
BULLETIN TYPE: Informational Only

FIELD SERVICE BULLETIN

SUBJECT: ASTRO® Digital APX™ 6000 and APX™ 6000XE (7/800 MHz) “Accy hardware not available” or “USB overcurrnt” error code when pressing PTT and may exhibit a loss of transmit audio thru a remote accessory.

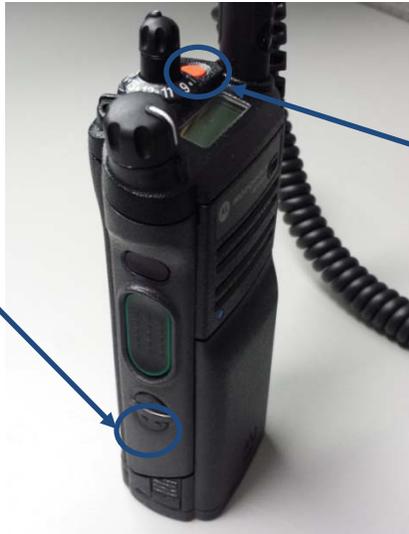
1. Press lower side button 5 times to initiate test mode.

2. Press top emergency button one time after lower side button is pressed to get radio in to test mode

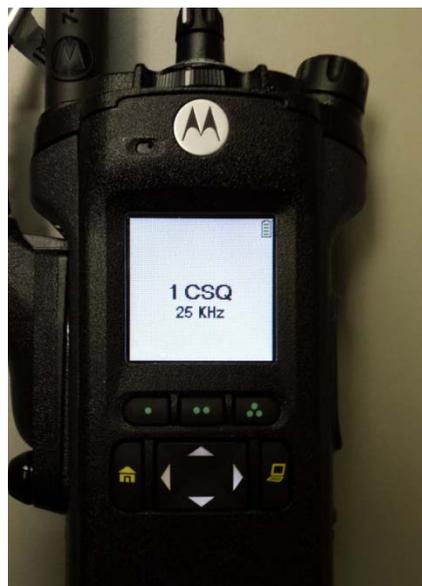
5. The top or front display should read "1 CSQ 25 KHz" to indicate the radio is in RF test mode channel 1.

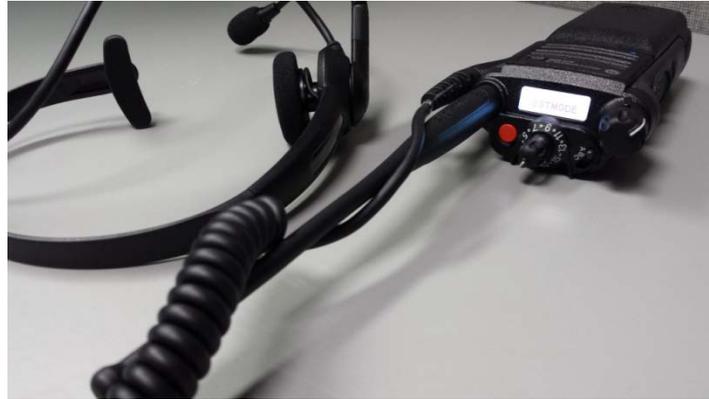
6. Wrap the straight portion of the accessory cable around the whip antenna at least 1 full turn.

7. Press the accessory PTT button 10-15 times while moving the cable around the antenna and watch for the top or front display to flash the error messages listed in this FSB. The error message clears after approximately 1 second.

8. If the error message does not appear, cycle the radio power and repeat the test 4 more times or until the message appears.
9. If no error message appears, the radio is good. No further action is required.
10. If error message appears, the radio is impacted and needs to be returned to Motorola Solutions, Inc. for repair (See resolution section for instructions to return for repair).
